STS-100 FLIGHT READINESS REVIEW

April 5, 2001

Ground Operations

STS-100 / OV-105 Operations Summary

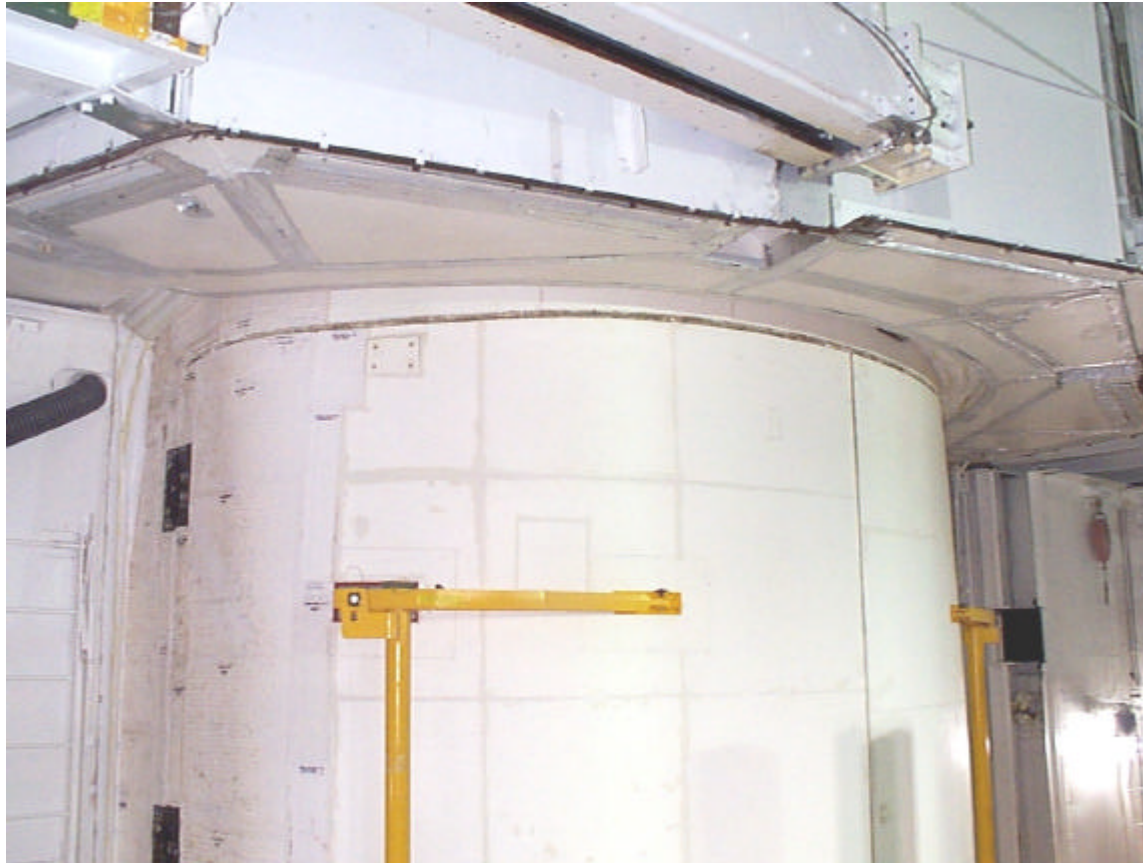
- Observation
 - OV-105 right hand Payload Bay (PLB) door contacted Pad-A Payload Changeout Room (PCR) door seal
 - No damage to PLB or PCR doors
- Concerns
 - Clearance for Payload installation
 - Shuttle Element dynamic clearances (Orbiter-ET-SRB)
 - Incomplete retraction of Tail Service Mast (TSM)

- Discussion
 - 1st time combination of MLP1, Pad-A, Lightweight ET, and OV-105 with no payload (Shuttle light)
 - Clearance of PLB door to PCR seal always minimal
 - Optics revealed PCR 0.4" low (relative to drawing)
 - TSM to orbiter aft optical measurements
 - STS-100 within historical database
 - Orbiter 0.35 inches high (high side of in-family)
 - All other Pad to orbiter umbilical mates nominal
 - No recent mods to Orbiter PLB doors, PCR, or MLP
- Actions Taken
 - Fault Tree analysis performed
 - No vehicle concern based on TSM data
 - PCR structural inspections performed with no anomalies noted

- Actions Taken (Cont'd)
 - Removed PCR door seal to open/close PLB doors
 - Seal prevents PCR contamination during launch
 - Optic measurements show discrepancies between actual vs ICD/drawing
 - PLB door length, PCR floor, Orbiter hatch elevations
- Actions in work
 - Obtain TSM to orbiter optics measurements post payload installation
 - Compare Pad support structure actual surveys to historical database
 - Resolve PCR/ICD discrepancies
 - These actions are no constraint to STS-100 processing and launch

- Risk Assessment
 - Clearance acceptable for
 - PLB door operations
 - Payload Integration operations
 - Payload Ground Handling Mechanism can compensate for any disparities and install payload
 - TSM measurements clear vehicle launch concerns

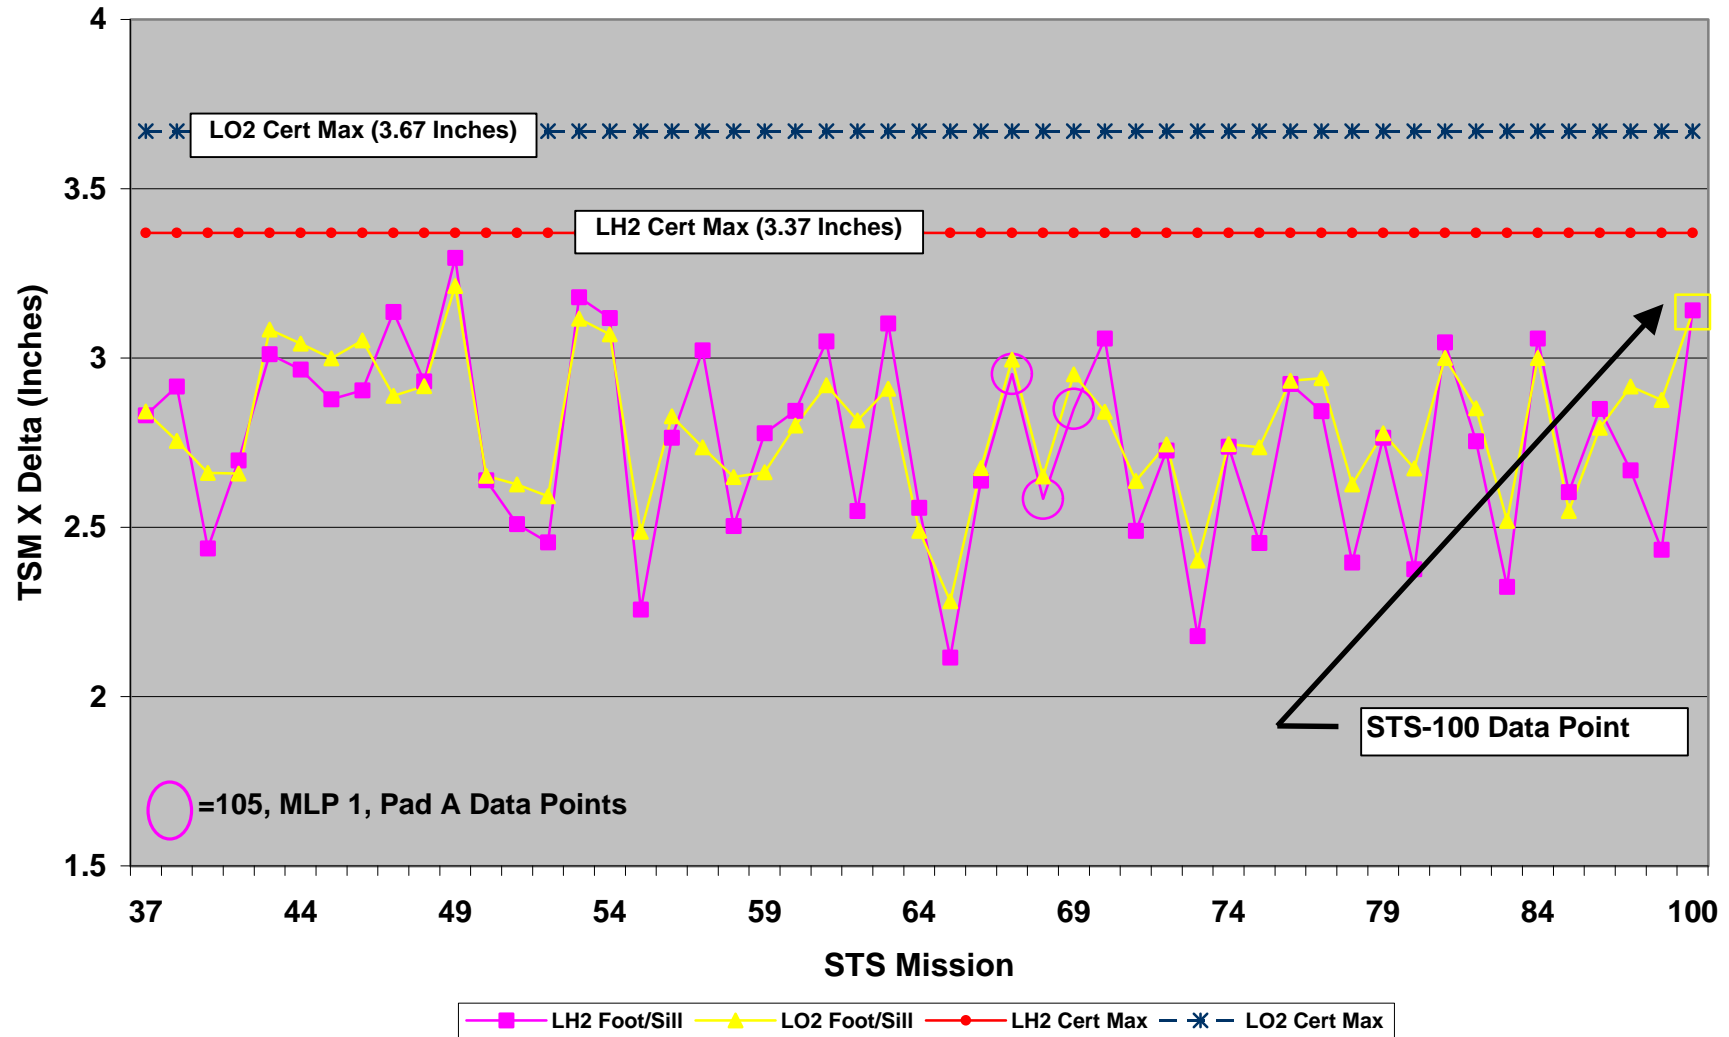
STS-100 TSM / ORBITER CHECK

TSM X Survey Delta - Distance Sill is below Orbiter Foot Receptical

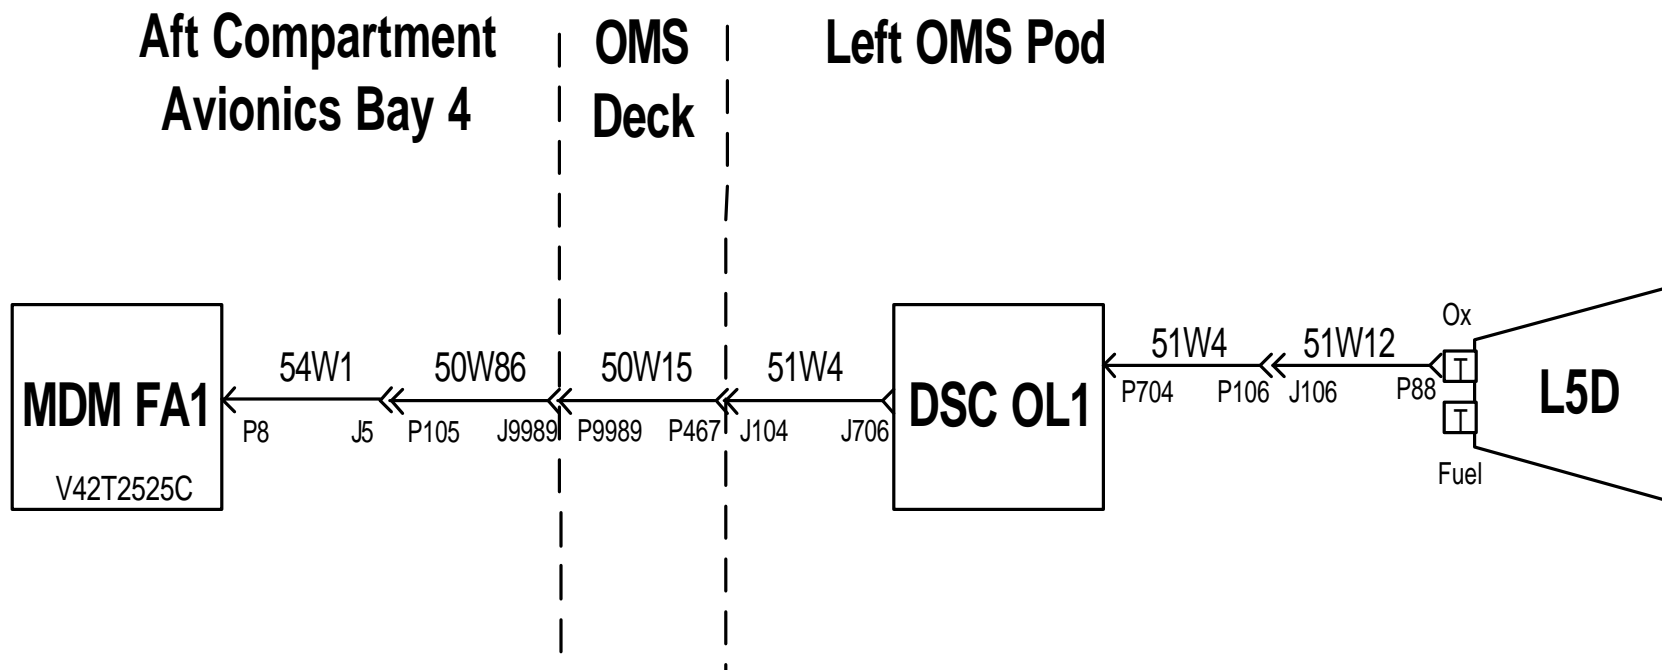
L5D Oxidizer Injector Temperature Block Diagram

- Observation
 - Vernier Thruster (S/N-102) L5D oxidizer injector temperature measurement V42T2525C exhibited erratic behavior during STS-68 mission
- Concerns
 - Inadvertent operation of RCS Redundancy Management to enunciate erroneous Oxidizer Leakage from this Vernier Thruster, resulting in deselection of L5D, and ultimately resulting in loss of all Vernier thruster usage

- Most Probable Cause
 - Intermittent electrical contact as a result of a faulty splice point, connector crimp or recessed pin
- Flight Effects
 - If thruster L5D oxidizer injector temperature measurement is erratic/failed low, RCS Redundancy Management (RM) would enunciate a failed leak and deselect L5D resulting in loss of all Vernier thruster usage
 - Will use fuel sensors to monitor both fuel and oxidizer due to close proximity

- Flight Effects (Cont'd)
 - General Memory (Pre-Approved) software patch would be uplinked into flight software to lower RCS RM oxidizer injector temperature leak limit from 130° F to 0° F
 - Allows deselection of failed thruster and subsequent reselection of all Vernier thrusters for usage
 - Oxidizer injector temperature sensors will not be used for leak detection
 - Visibility to the crew of this condition would be evident by the erratic behavior of oxidizer temperature measurement and low-bias when compared with fuel injector temperature measurement
 - Available on PFS and BFC GNC SYS SUMM1 pages and Caution & Warning
